SUPPORT NOTE

SN-101

Tightening Sun EC1.3W Handles

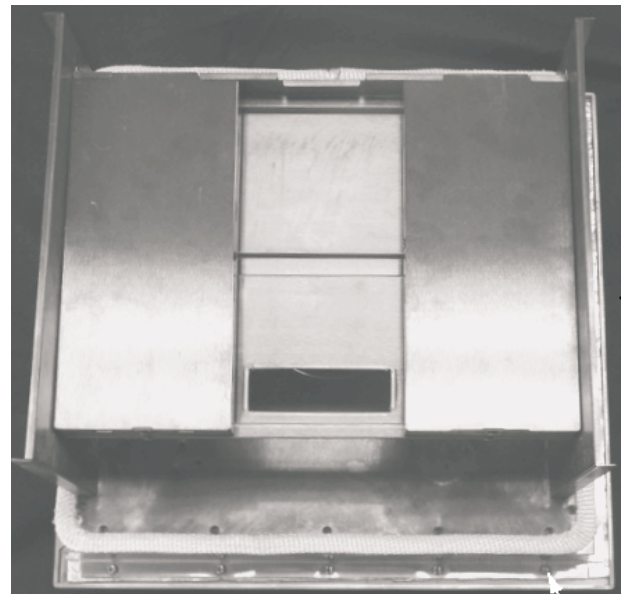
#4 Nuts (25 plcs)

Over time the Sun EC1.3W oven door handles can work loose. This support note provides directions for remedying the problem. These repairs should not be attempted while the oven door is still at elevated temperatures. All new Sun EC1.3W oven doors shipped after September 2001, have the change already incorporated

1. All of the #4 nuts and lock washers around the outside edge need to be removed so that the inside of the door can be lifted away from the front. In addition, the fiberglass rope needs to be removed from the purge hole so that friction on the high temperature cable does not hinder lifting. Note: There is no need to remove the load boxes or the brackets (internal or external) in order to tighten the handles.

2. After lifting the inside of the door away, it is shifted as needed to gain access to the beveled screws that hold the handles in place from the inside of the door.

3. One beveled screw should be replaced at a time with a #8-32 x 5/8" screw, #8 split lock washer, and #10 flat washer. Otherwise, alignment is easily lost and the repair is much more difficult.
