SUPPORT NOTE

SN-101

Tightening Sun EC1.3W Handles

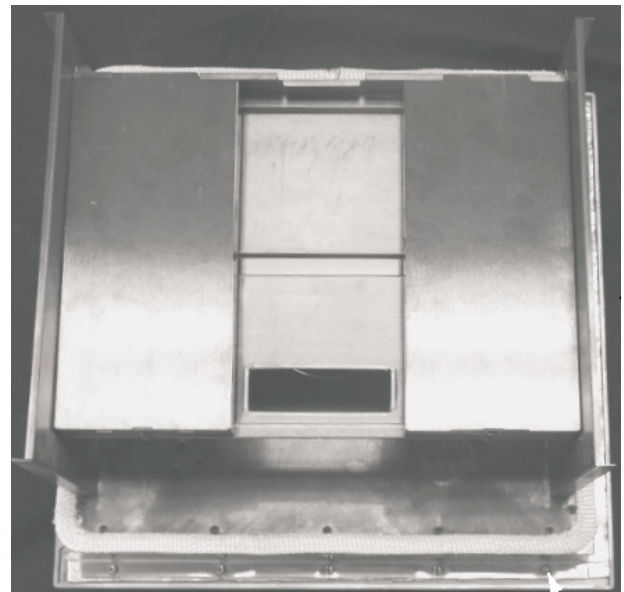
#4 Nuts (25 plcs)

1. All of the #4 nuts and lock washers around the outside edge need to be removed so that the inside of the door can be lifted away from the front. In addition, the fiberglass rope needs to be removed from the purge hole so that friction on the high temperature cable does not hinder lifting. Note: There is no need to remove the load boxes or the brackets (internal or external) in order to tighten the handles.
